# Inspection Report

**Property Address:**  
200 Some Place Road  
Carrboro NC 27510

**KO Home Inspections LLC**

<b>Date:</b> 11/20/2016	<b>Time:</b> 10:30 AM	<b>Report ID:</b> 11172016200WildOak
<b>Property:</b> 200 Some Place Road Carrboro NC 27510	<b>Customer:</b> John Doe	<b>Real Estate Professional:</b>

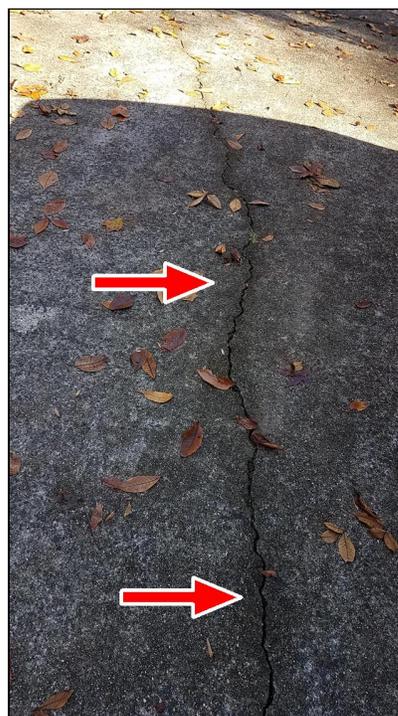
An open crack has formed in the cement driveway in front of the house. It is not uncommon for cement driveways to have some mild cracking from expansion during construction or settling over time. The crack does not pose a hazard at this time but should be monitored for further movement. If you are concerned about this crack or if you notice further movement especially a raised edge that can be a tripping hazard contact a masonry contractor for evaluation and repairs.

1.0 Item 1(Picture) driveway crack

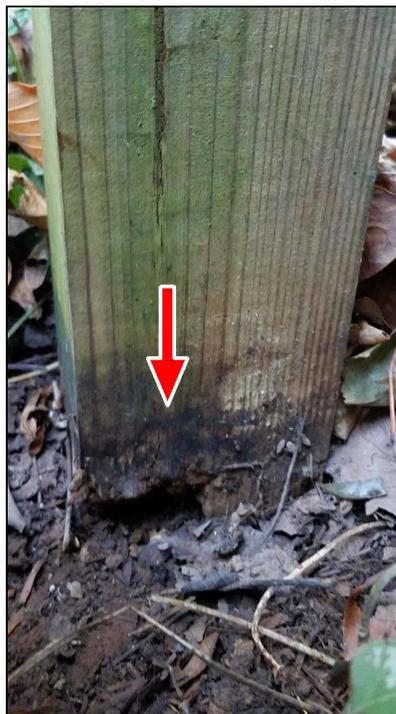
(1) One or more of the wooden posts that support the back deck have started to decay and should be replaced. Have a licensed contractor evaluate and repair the deck. If not corrected the posts will continue to decay eventually leading to the deck collapsing.

1.2 Item 1(Picture) rotting deck post

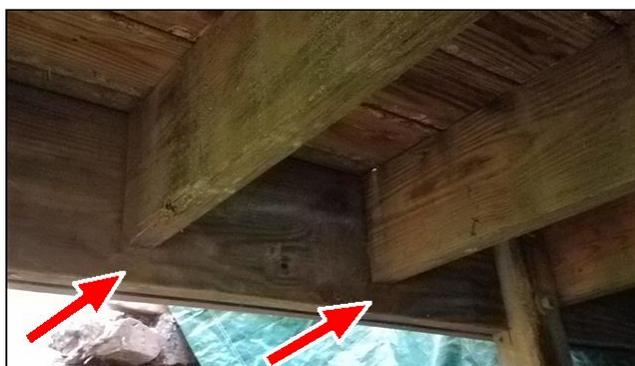
(2) The floor joists for the back deck are connected to the support girder with nails only. This type of connection is weak and there have been many instances of decks collapsing under heavy loads (like a large group of people) when connected in this way. I recommend the joist to girder connections be upgraded to metal joist hangers or a wooden ledger strip by a licensed contractor.

1.2 Item 2(Picture) Missing hangers or ledger

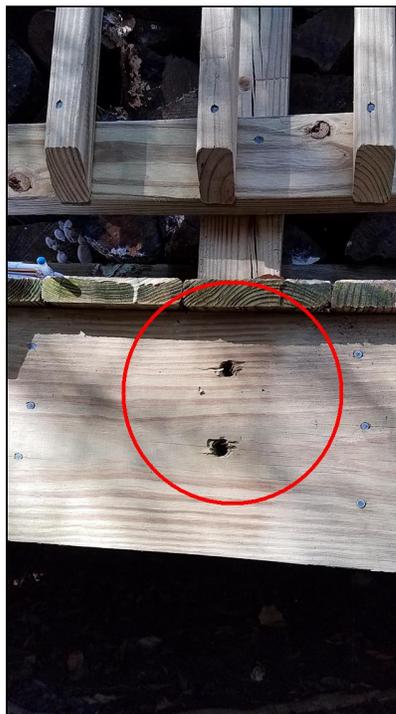
(3) One of the deck railing support posts on the back deck is missing the bolts (typically 5/8" galvanized carriage bolts) that secure it to the deck. Have a carpenter or handyman install the missing bolts to prevent the railing from giving way unexpectedly causing falling injury.

1.2 Item 3(Picture) missing post bolts

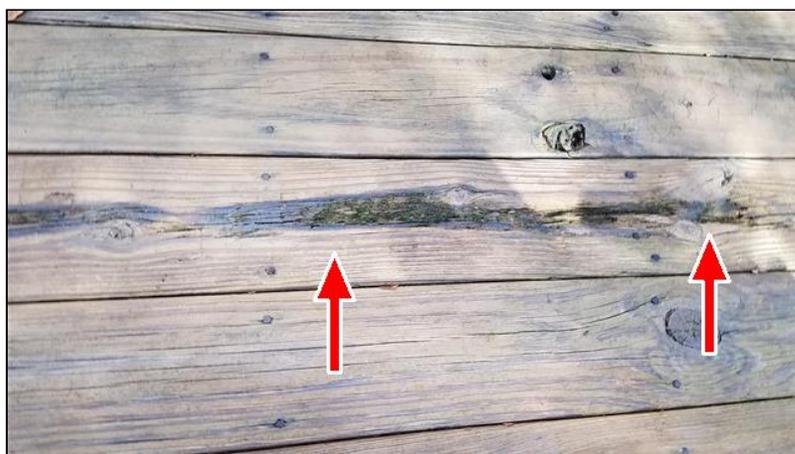
(4) The decking on the back deck has some boards that are deteriorated and should be replaced to prevent further decay and eventual failure. Have a qualified contractor or handyman replace the weathered and decayed decking.

1.2 Item 4(Picture) decayed deck board

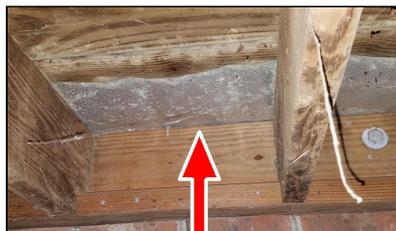
(6) The metal flashing between the house and the deck band is corroded and starting to fail. This flashing is needed to keep water from penetrating to the interior framing of the house and causing hidden decay and structural damage. Have a licensed contractor replace the deck flashing when the other deck repairs are made.

1.2 Item 5(Picture) corroded flashing

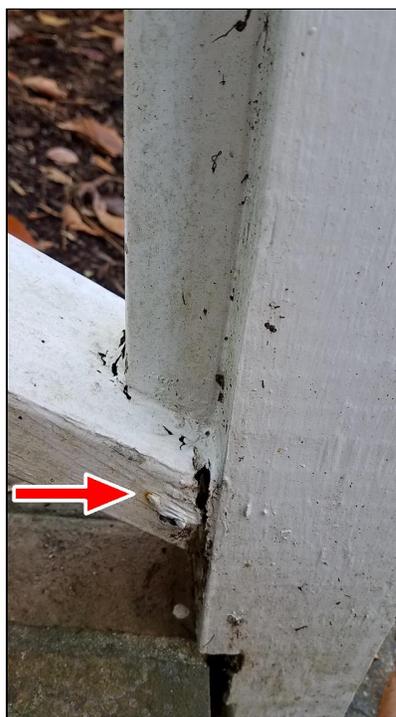
(1) The railing of the front porch was noted to be decayed and may give way unexpectedly causing an injury if not corrected. Additionally the balusters of the railing are spaced over 4" wide which can injure small children and pets that fall through the openings. Have a qualified contractor or carpenter repair the railing for safety.

1.3 Item 1(Picture) rotting railing

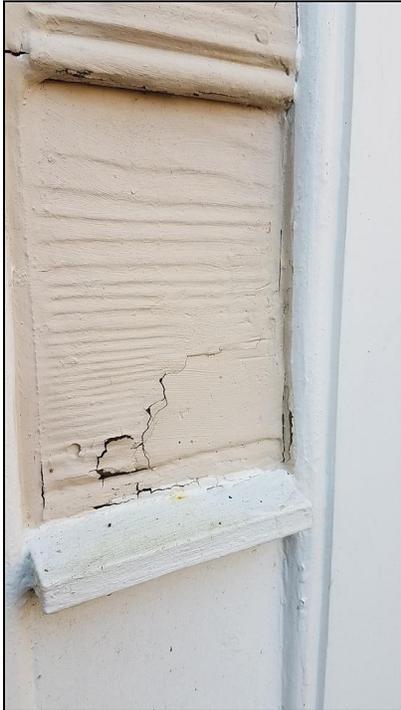
(1) To prevent water entering the exterior wall cladding and causing additional decay to adjacent siding and wall framing have a siding contractor repair or replace the deteriorated siding at the following locations:

1.4 Item 1(Picture) front siding damage

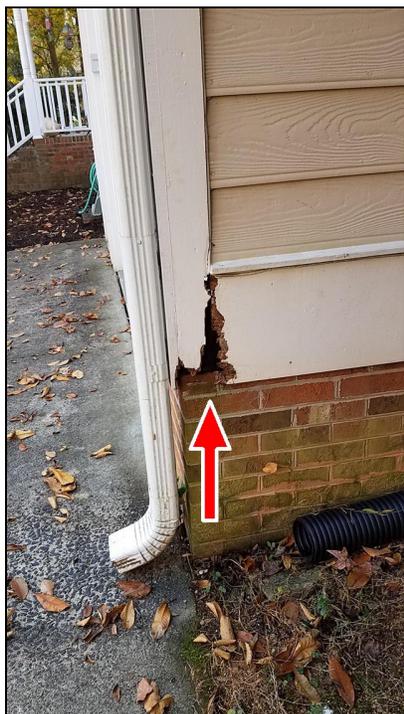
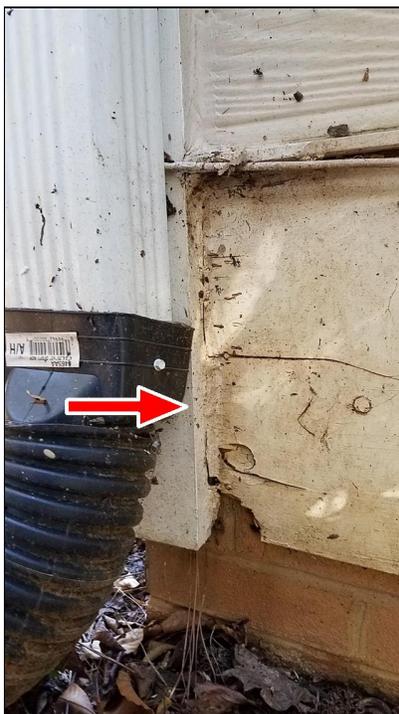
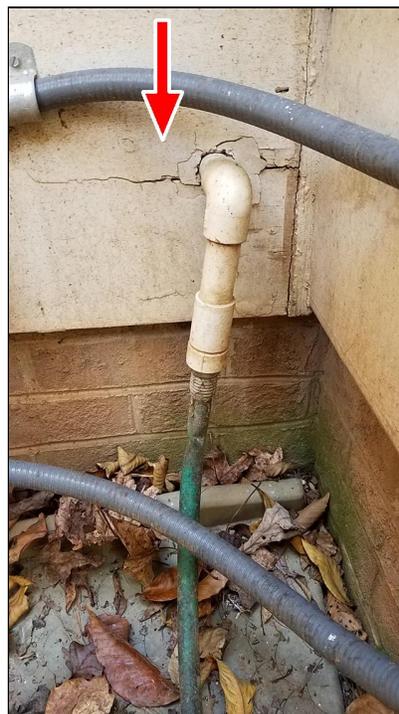
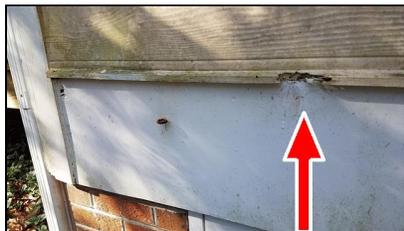
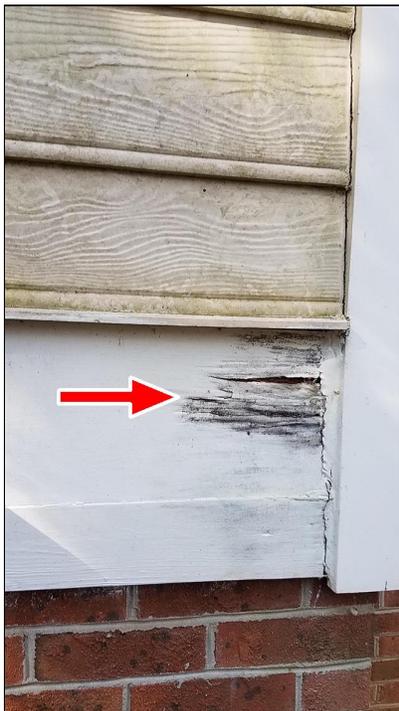
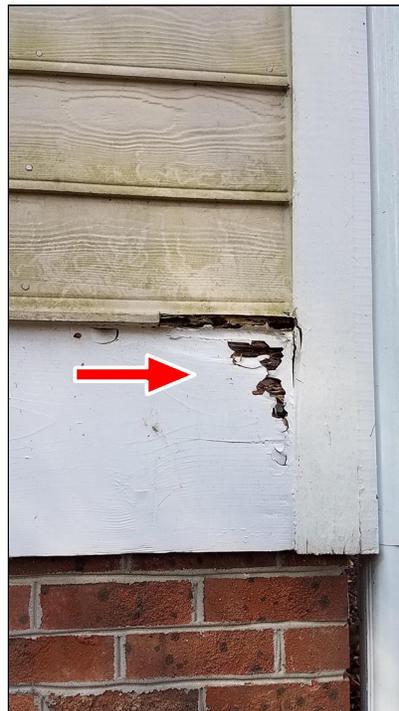
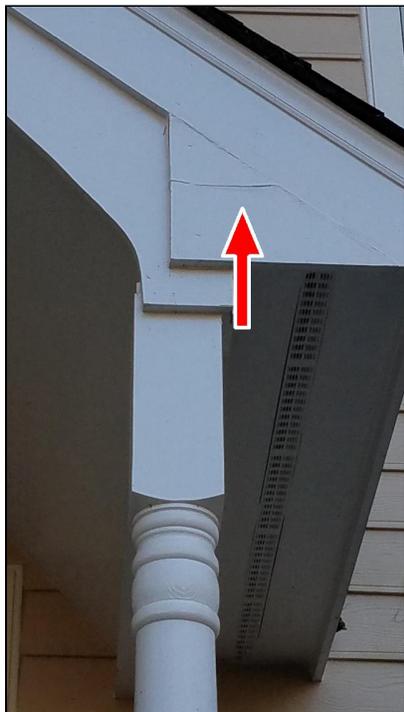
(2) The wood trim is rotting and deteriorated in various areas around the perimeter of the home. I recommend a qualified siding contractor evaluate and repair or replace the failing trim.

1. The right front corner of the garage
2. The back right corner skirt board and drip molding
3. back of house skirt board cracked
4. Left side of house over crawlspace access door
5. Left side middle skirt board
6. Left side front corner skirt board
7. cracked soffit trim front porch gable
8. shingle molding left side gable at roof

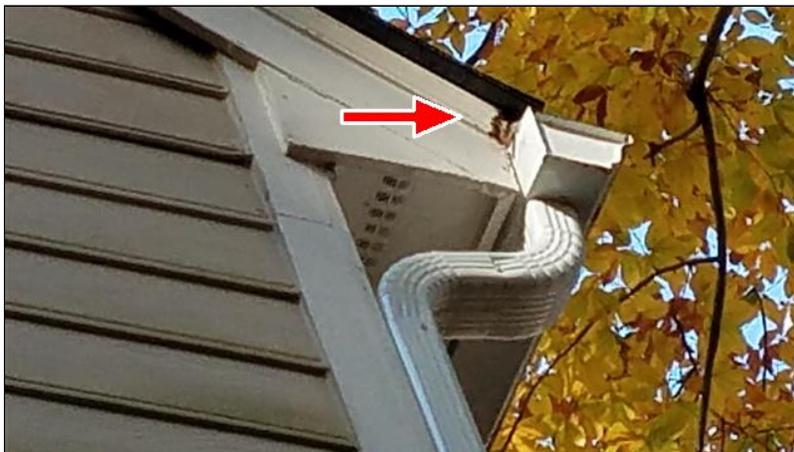
1.4 Item 11(Picture) shingle mold rotten

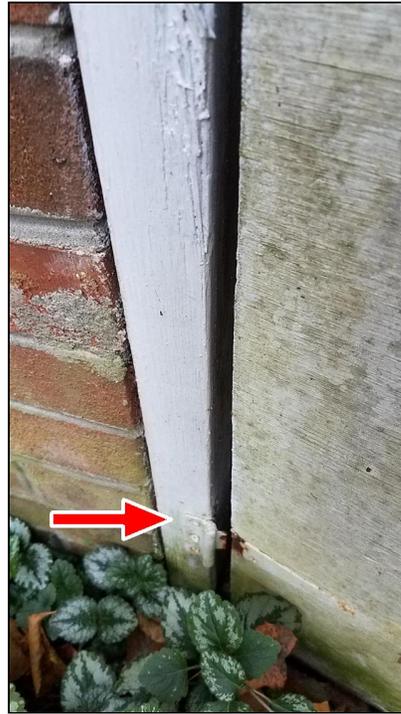
(1) The access door to the crawlspace has a broken lower hinge. I recommend repair as needed.

1.6 Item 1(Picture) broken hinge crawlspace door

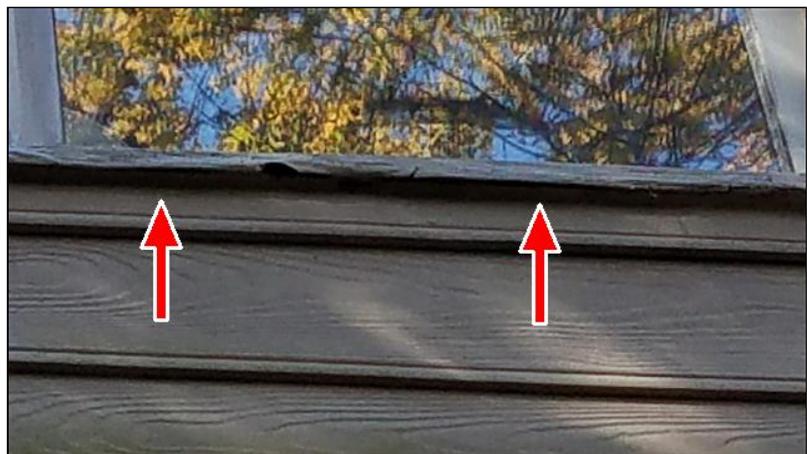
(1) The sill of the second story window on the left side of the home is decayed and should be repaired or replaced by a qualified contractor or window specialist.

1.7 Item 1(Picture) decayed sill 2nd floor

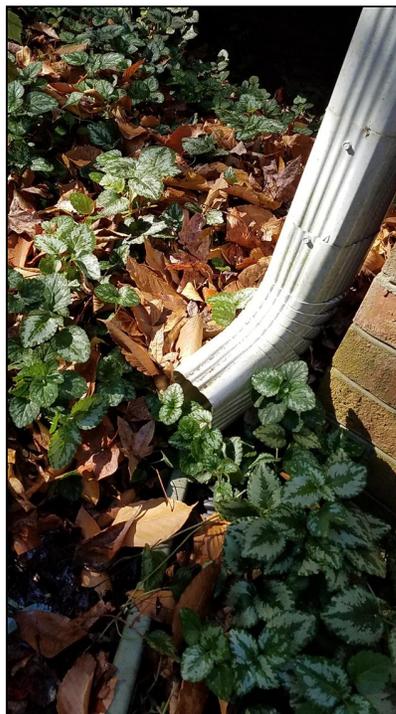
2.4 Item 1(Picture)

(1) The downspouts need an extension and a buried drain line to carry water away from the home at the back corners. Water that is allowed to soak the ground next to a homes foundation can lead to costly repairs for decayed wood or foundation cracks. Have a handyman or contractor pipe the discharge from the downspouts away from the home.

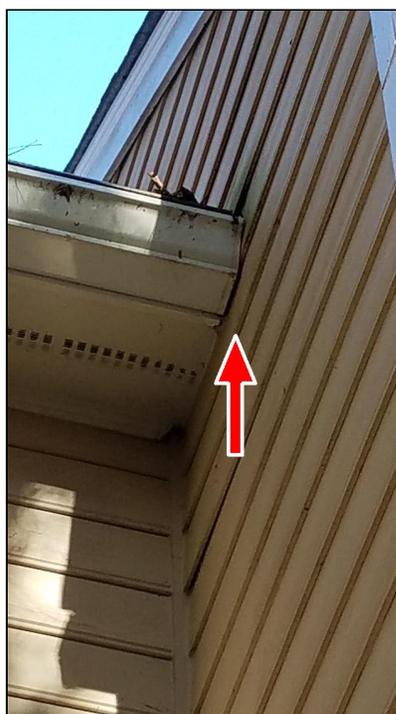
(2) The gutter on the back of the garage is touching the siding of the house at the inside corner. This is a poor installation practice that can lead to water overflowing the gutter, soaking the wall and deteriorating the siding. There should be a gap of 1-2 inches between the gutter end and the siding to prevent this. Have a gutter specialist repair this condition.

2.4 Item 2(Picture) gutter touching siding

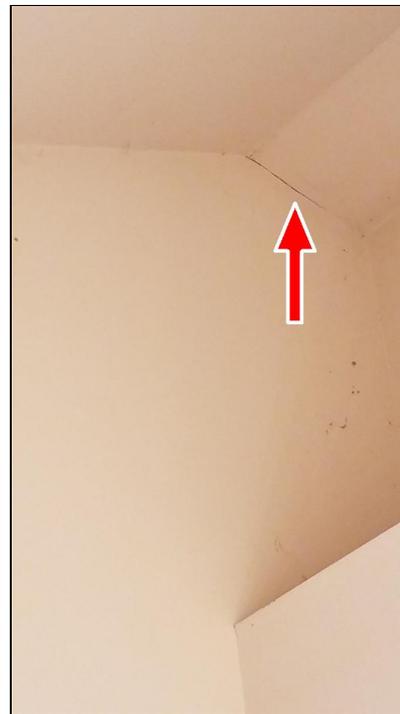
There is a crack in the drywall in the master bath ceiling. Cracks can occur for a variety of reasons such as substandard drywall finishing, moisture in drywall seams, or cracks can be from movement/settlement of the home. Have a painter repair and paint the crack as needed. This crack appears cosmetic but if you are concerned the crack is from movement and is structural have an engineer evaluate the home.

4.0 Item 1(Picture) crack in ceiling

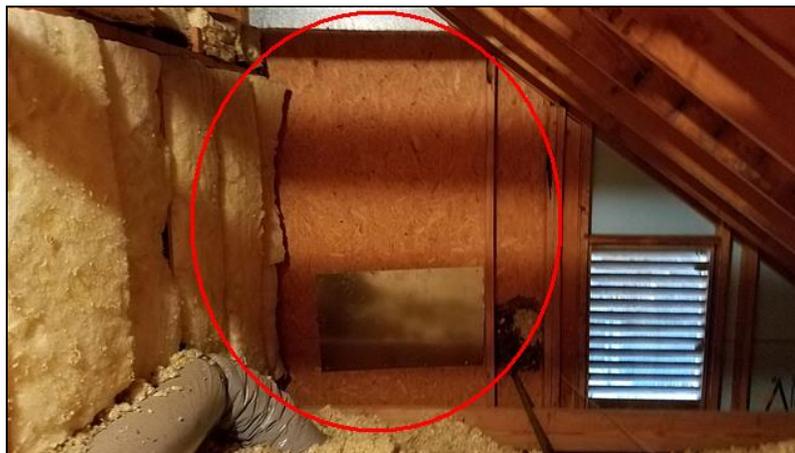
4.1 Item 1(Picture) evaluate

(1) Some repairs have been made in the past to the gas fireplace chase in the attic space over the master bedroom. The chase has OSB and sheet metal pieces patching in this area that appears substandard. Have a licensed contractor evaluate and fix as necessary.

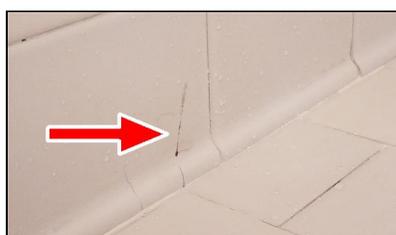
(2) A cracked tile was noted in the master bath shower. Damaged tiles can let water from the shower enter the wall or floor cavities and hidden decay and mold growth can result. Have an experienced tile setter replace the damaged tiles.

4.1 Item 2(Picture) cracked shower tile

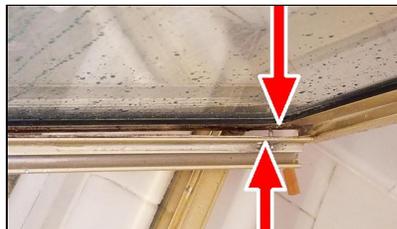
4.5 Item 1(Picture)

(3) The drip tray at the bottom of the shower door in the master bathroom is separating from the door. This can lead to water leaking under the door and onto the floor. Have a contractor repair or replace the drip tray.

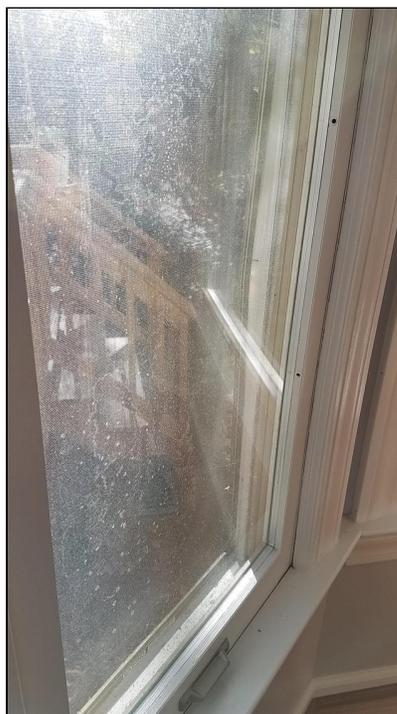
4.6 Item 1(Picture)

(2) The left side of the bay window in the breakfast nook was fogged. "Fogging" is condensation trapped between two insulated glass panes and is caused by broken vapor seals. Fogging or cloudiness in windows may not be evident at the time of inspection but could appear during different weather conditions. Consider hiring a window specialist to evaluate all windows for broken seals and repairing as needed.

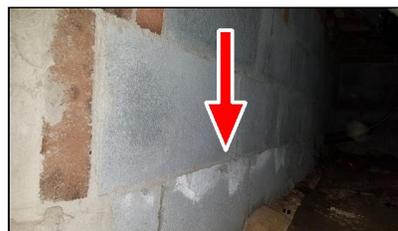
(1) White efflorescence (powder substance) on block wall indicates moisture is in contact with the masonry. This does not necessarily indicate that intrusion will occur. I recommend checking the gutters and the downspout drain lines for proper operation. Also, a water proofing paint could be applied to the exterior side of the block if necessary. Efflorescence is found on many homes without water intrusion occurring inside the home. But, it should alert you to the possibility that future steps may be needed.

5.0 Item 1(Picture) efflorescence

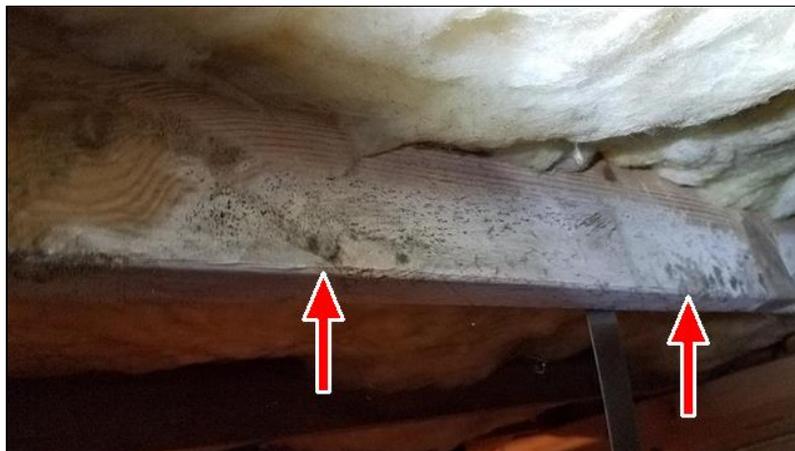
(1) There is mold/fungi growth on the floor system in the crawlspace. The underlying cause of this growth is high humidity caused by moisture, wet conditions or standing water. Excessive moisture and a chronically moist environment will cause the moisture content of wood to increase. Wood with moisture content of 19% or greater provides the perfect conditions for wood decay fungi to grow. The activity of wood decay fungi results in wood rotting, destroying the structural integrity of the wood components in the crawl space. I did not test or determine if this growth is or is not a health hazard. Fungi growth can result in poor air quality in the home. Contact a mold inspector or expert for investigation or correction if needed. Monitor your crawlspace periodically as part of a normal maintenance program for your home.

5.3 Item 1(Picture) mold/fungi

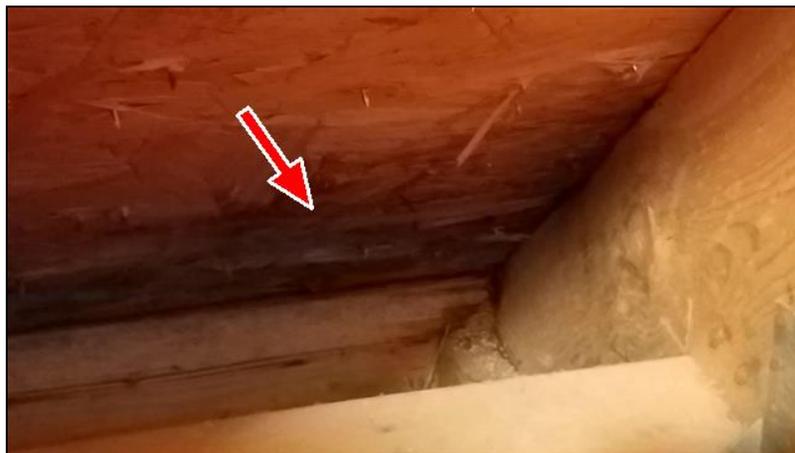
(1) The roof sheathing in the attic over the garage at the front of the house is stained from a roof leak. I am unable to determine if the leak is old and been repaired or still remains active. Although the damage to this area is not significant enough to require replacing at this time, an active leak can cause structural damage and decay of building components if not corrected. Have a licensed roofing contractor evaluate the roof and make any necessary repairs to keep water out of the attic.

5.5 Item 1(Picture) water penetration

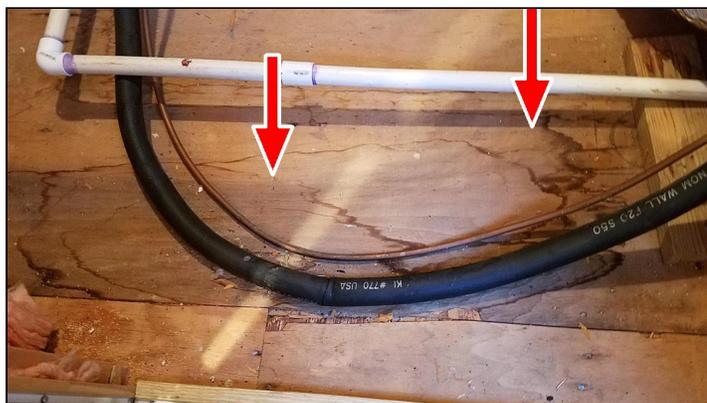
(4) There are water stains on the attic flooring under the HVAC air handler located in the attic above the master bedroom. It appears that the stains are from condensation dripping off the HVAC piping. While there was no active water leaking during the inspection and the damage is not significant, I could not determine if the condition causing the water has been corrected. Water actively entering into the attic can cause damage to ceilings, wood components and insulation. Monitor the area for signs of water and have an HVAC technician evaluate the air handler and make sure that any condensation that forms is drained to the exterior.

5.5 Item 2(Picture) water stains

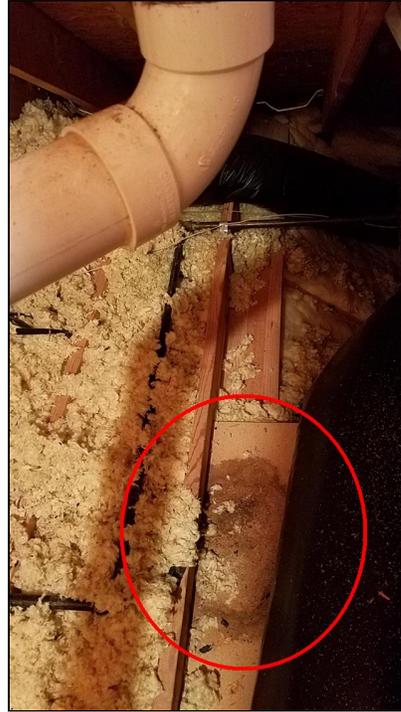
(5) I noted a water stain on the attic flooring above the master bath directly below where a plumbing vent pipe penetrates the roof. This frequently happens if the pipe flashing boot is old and damaged allowing water to drip into the attic around the pipe. There were no signs of active water leaks at the time of the inspection and the pipe flashing boot was in good shape. Have the home owner disclose if any repairs were made to correct a leak around the vent pipe. Also check the area for water leaks after a heavy rain to be sure the problem has been fixed.

5.5 Item 3(Picture) leak stain

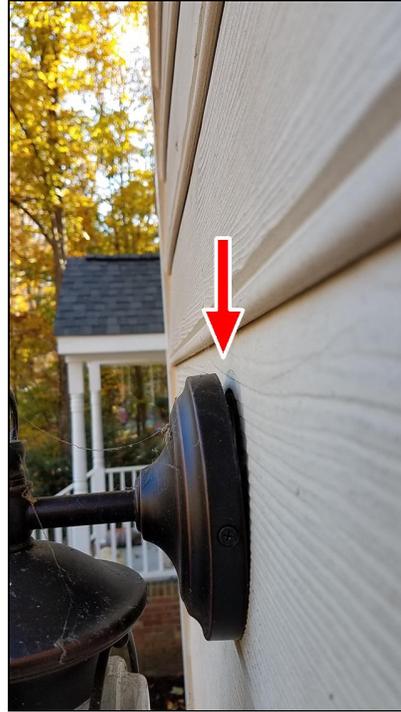
(1) The exterior light above the garage entry door is loose from the wall. Have an electrical contractor secure the light and seal the flange to the house so water can not leak into the fixture causing a short.

7.5 Item 1(Picture) loose exterior light

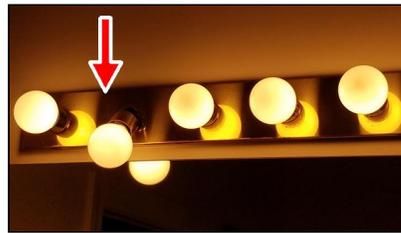
(2) The light fixture in the master bathroom is damaged and needs to be replaced by a licensed electrical contractor.

7.5 Item 2(Picture) damaged light fixture

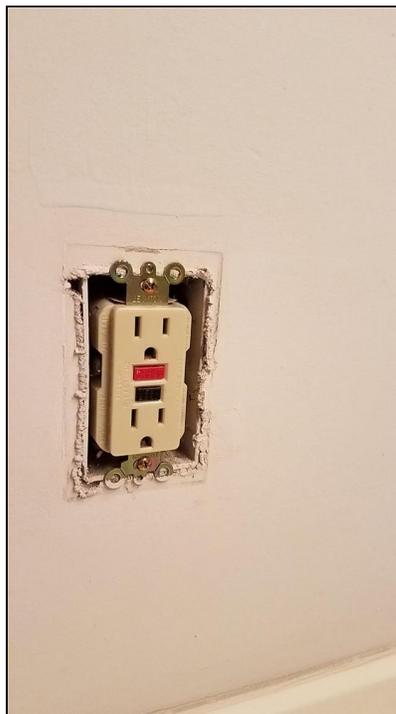
(1) A receptacle in the master bath is missing its cover plate that prevents accidental contact with live electrical conductors. This is a dangerous shock hazard that should be corrected. Have an electrician or handyman install a cover plate.

7.6 Item 1(Picture) missing cover plate

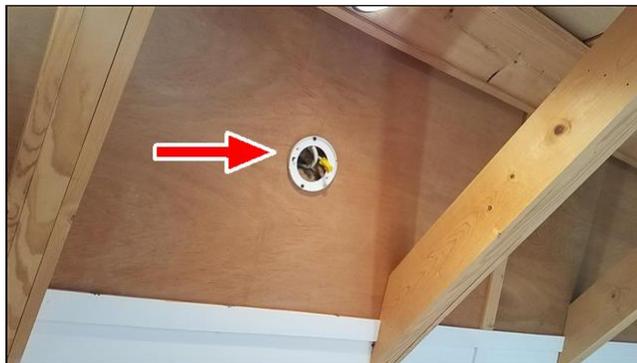
(3) A smoke alarm has been disconnected or is missing in the finished attic room above the master bed room. Have a handyman or contractor install a new smoke detector for safety.

7.8 Item 1(Picture) missing smoke detector

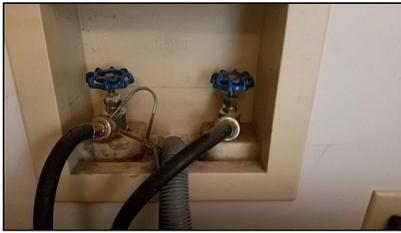
6.1 Item 1(Picture)

(2) The washing machine shut-off valves in the utility closet are loose within the wall. Have a plumber or contractor secure the shut-off to prevent damage to distribution pipes.
