# Inspection Report

**Property Address:**  
200 Some Place Road  
Carrboro NC 27510

**KO Home Inspections LLC**

<b>Date:</b> 11/20/2016	<b>Time:</b> 10:30 AM	<b>Report ID:</b> 11172016200WildOak
<b>Property:</b> 200 Some Place Road Carrboro NC 27510	<b>Customer:</b> John Doe	<b>Real Estate Professional:</b>

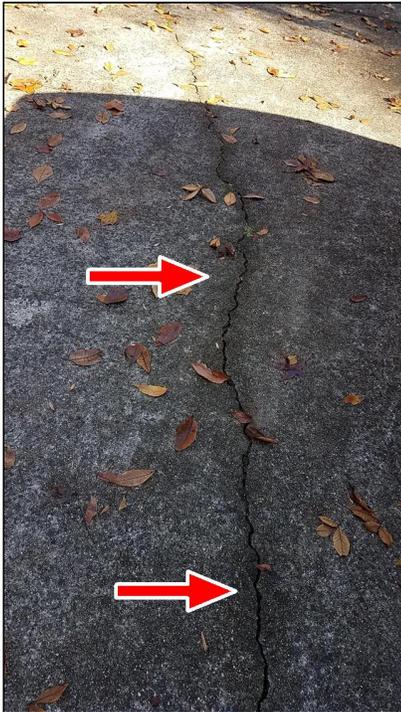
1.0 Item 1(Picture) driveway crack

An open crack has formed in the cement driveway in front of the house. It is not uncommon for cement driveways to have some mild cracking from expansion during construction or settling over time. The crack does not pose a hazard at this time but should be monitored for further movement. If you are concerned about this crack or if you notice further movement especially a raised edge that can be a tripping hazard contact a masonry contractor for evaluation and repairs.

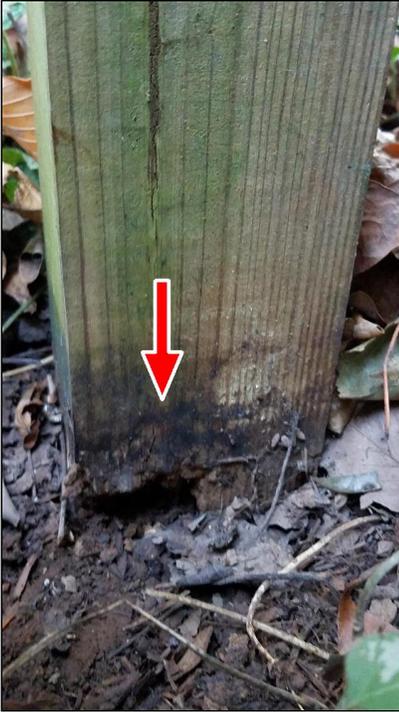
1.2 Item 1(Picture) rotting deck post

(1) One or more of the wooden posts that support the back deck have started to decay and should be replaced. Have a licensed contractor evaluate and repair the deck. If not corrected the posts will continue to decay eventually leading to the deck collapsing.

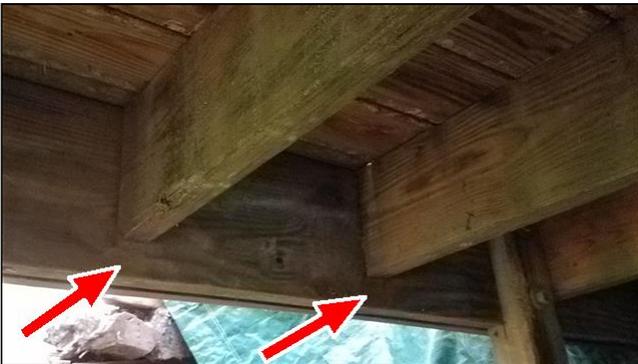
1.2 Item 2(Picture) Missing hangers or ledger

(2) The floor joists for the back deck are connected to the support girder with nails only. This type of connection is weak and there have been many instances of decks collapsing under heavy loads (like a large group of people) when connected in this way. I recommend the joist to girder connections be upgraded to metal joist hangers or a wooden ledger strip by a licensed contractor.

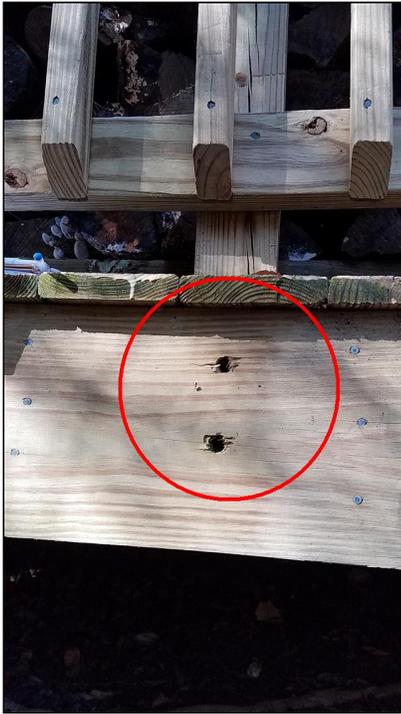
1.2 Item 3(Picture) missing post bolts

(3) One of the deck railing support posts on the back deck is missing the bolts (typically 5/8" galvanized carriage bolts) that secure it to the deck. Have a carpenter or handyman install the missing bolts to prevent the railing from giving way unexpectedly causing falling injury.

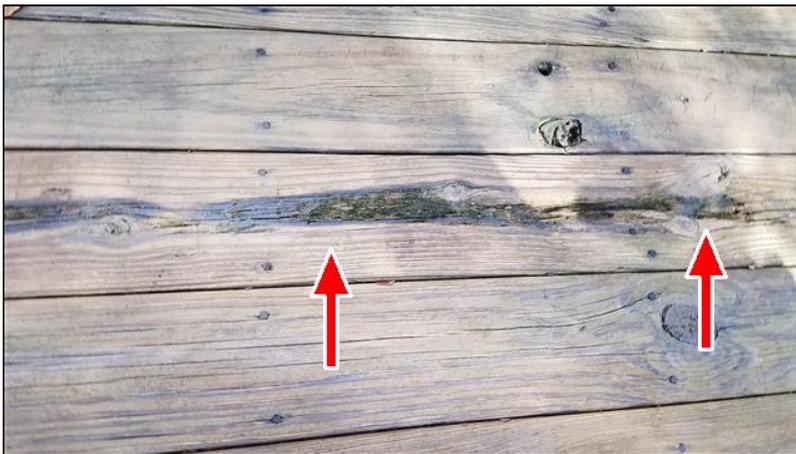
1.2 Item 4(Picture) decayed deck board

(4) The decking on the back deck has some boards that are deteriorated and should be replaced to prevent further decay and eventual failure. Have a qualified contractor or handyman replace the weathered and decayed decking.

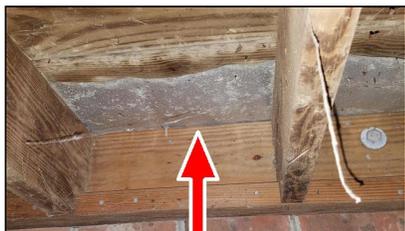
1.2 Item 5(Picture) corroded flashing

(6) The metal flashing between the house and the deck band is corroded and starting to fail. This flashing is needed to keep water from penetrating to the interior framing of the house and causing hidden decay and structural damage. Have a licensed contractor replace the deck flashing when the other deck repairs are made.

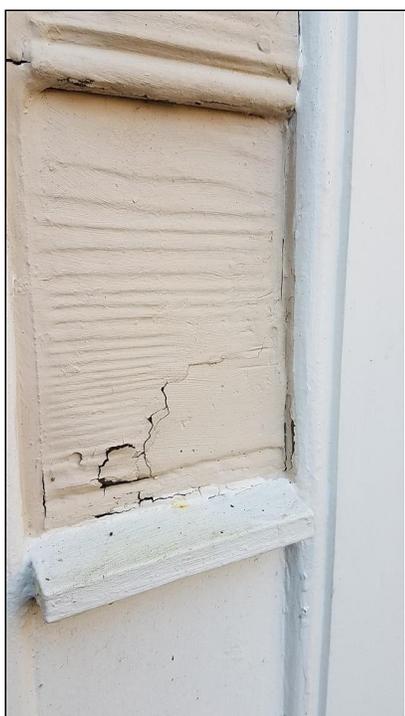
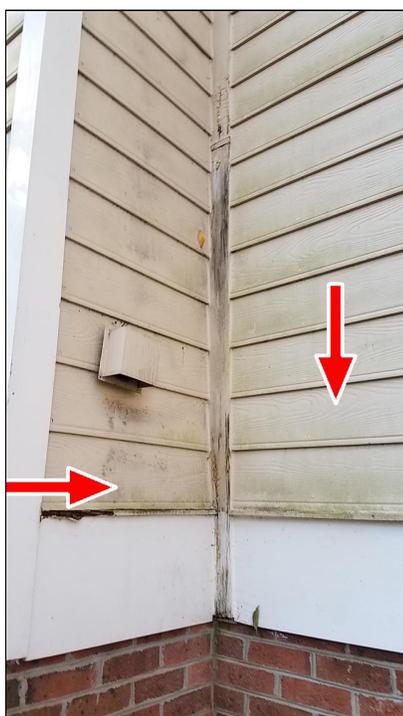
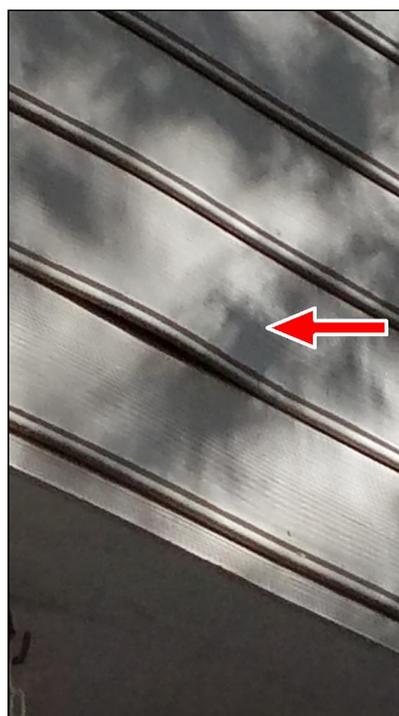
(1) To prevent water entering the exterior wall cladding and causing additional decay to adjacent siding and wall framing have a siding contractor repair or replace the deteriorated siding at the following locations:

1. Front of house to the left of the garage door
2. The left side of the house at the inside corner with the chimney chase
3. Above the deck at the back of the house

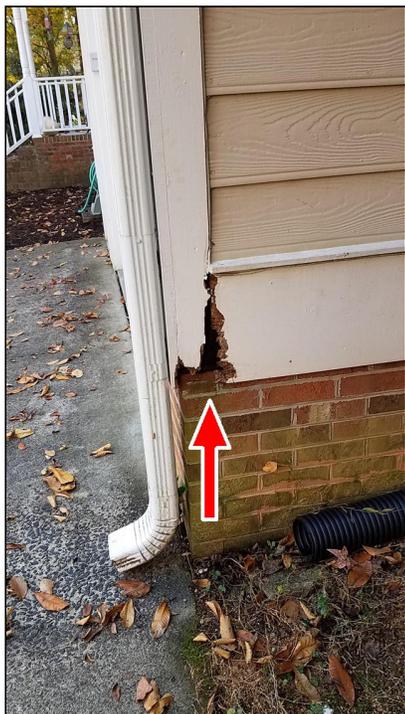
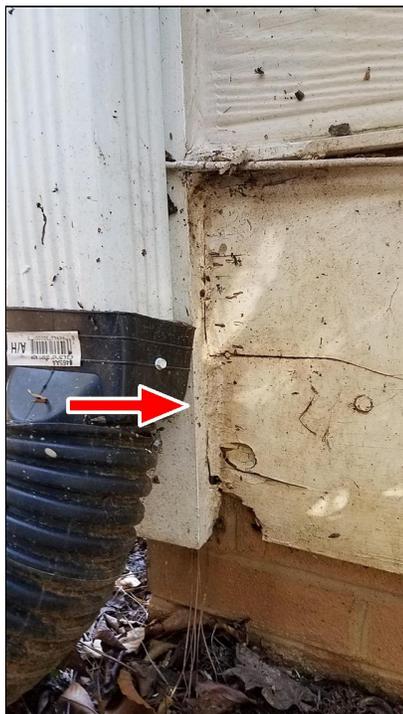
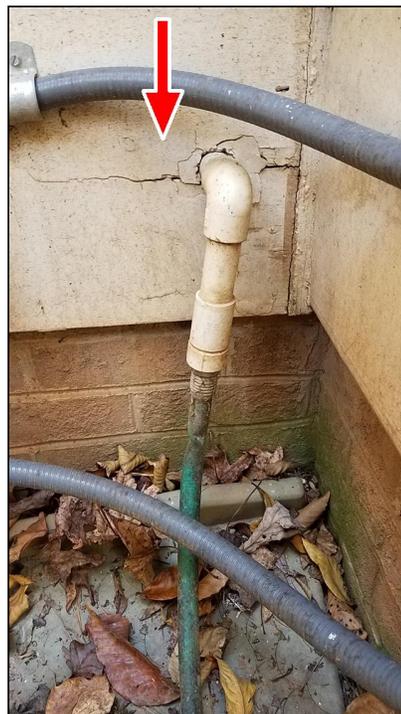
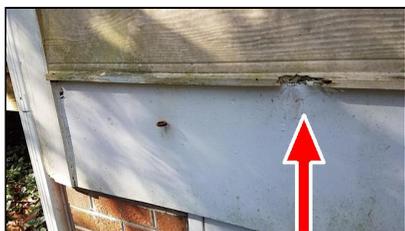
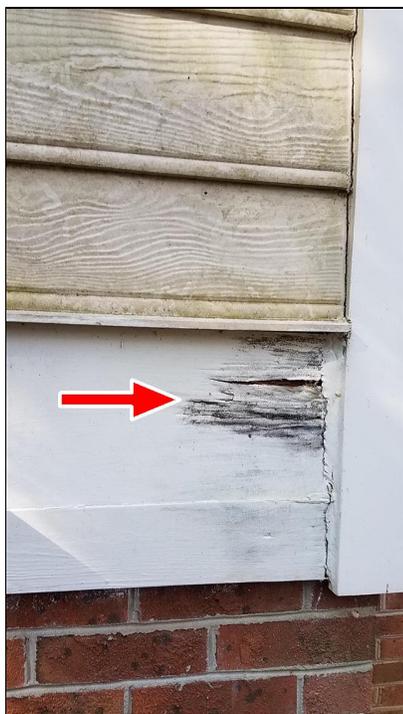
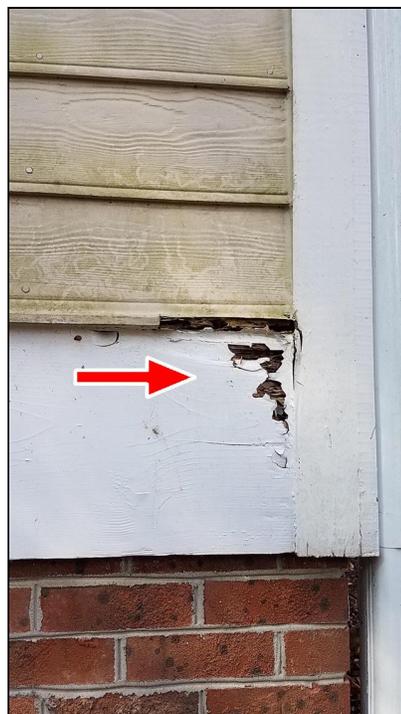
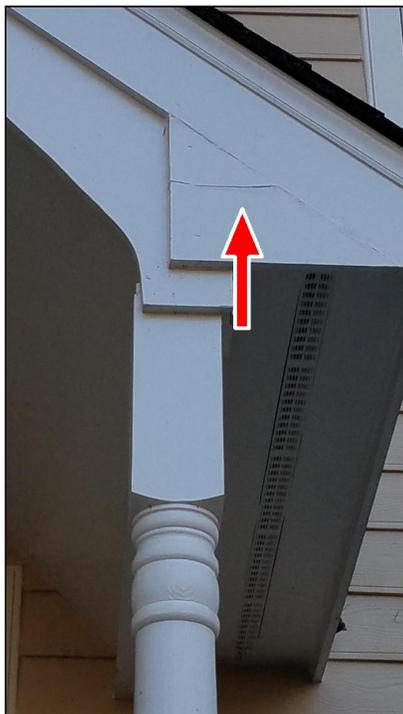
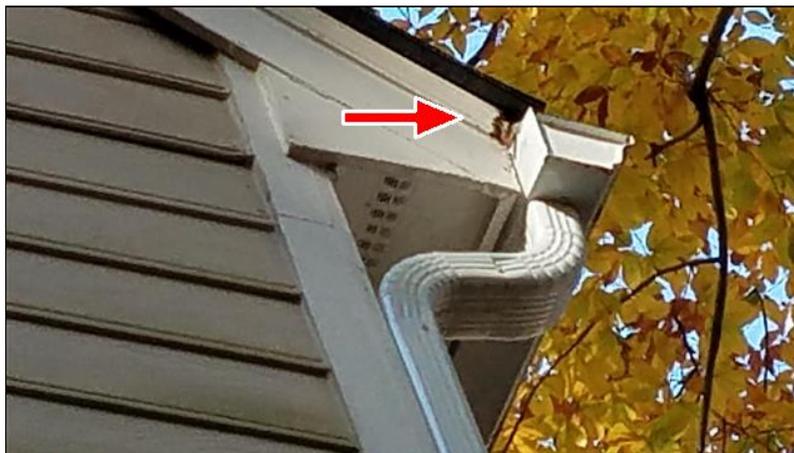
(2) The wood trim is rotting and deteriorated in various areas around the perimeter of the home. I recommend a qualified siding contractor evaluate and repair or replace the failing trim.

1. The right front corner of the garage
2. The back right corner skirt board and drip molding
3. back of house skirt board cracked
4. Left side of house over crawlspace access door
5. Left side middle skirt board
6. Left side front corner skirt board
7. cracked soffit trim front porch gable
8. shingle molding left side gable at roof

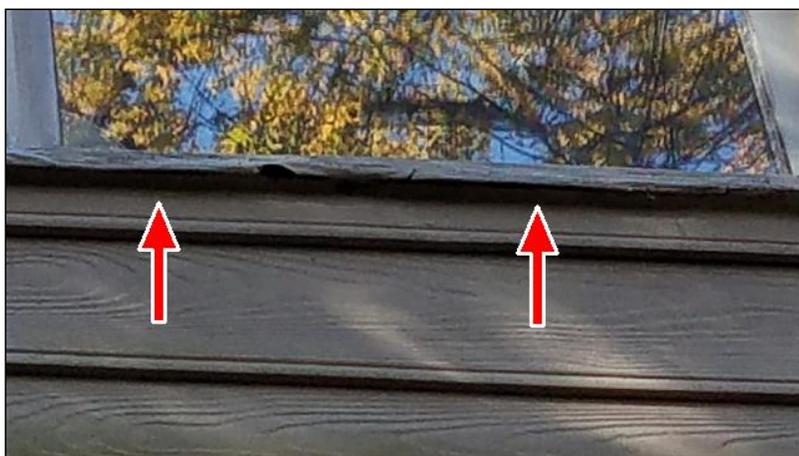
1.7 Item 1(Picture) decayed sill 2nd floor

(1) The sill of the second story window on the left side of the home is decayed and should be repaired or replaced by a qualified contractor or window specialist.

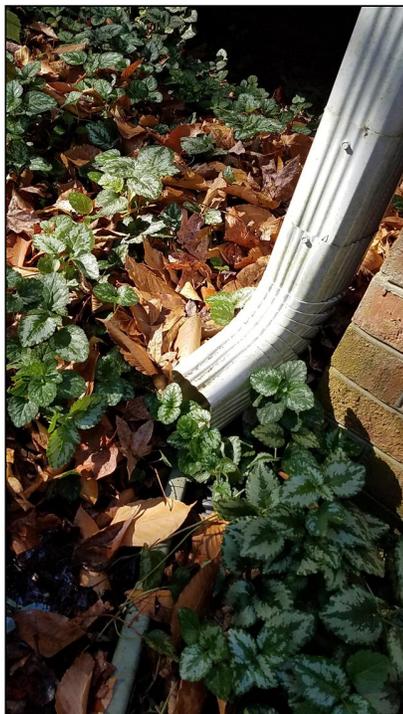
2.4 Item 1(Picture)

(1) The downspouts need an extension and a buried drain line to carry water away from the home at the back corners. Water that is allowed to soak the ground next to a homes foundation can lead to costly repairs for decayed wood or foundation cracks. Have a handyman or contractor pipe the discharge from the downspouts away from the home.

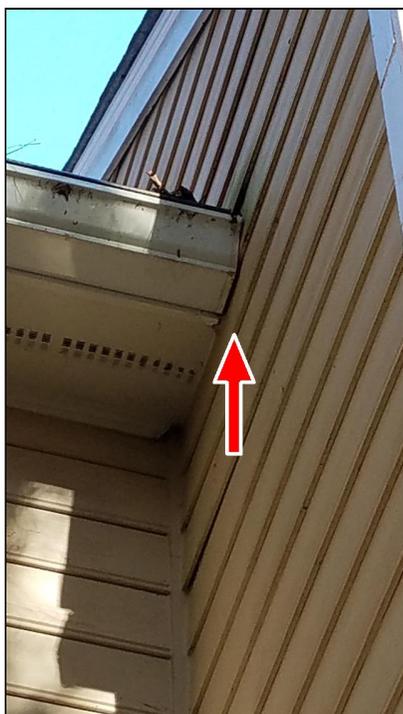
2.4 Item 2(Picture) gutter touching siding

(2) The gutter on the back of the garage is touching the siding of the house at the inside corner. This is a poor installation practice that can lead to water overflowing the gutter, soaking the wall and deteriorating the siding. There should be a gap of 1-2 inches between the gutter end and the siding to prevent this. Have a gutter specialist repair this condition.

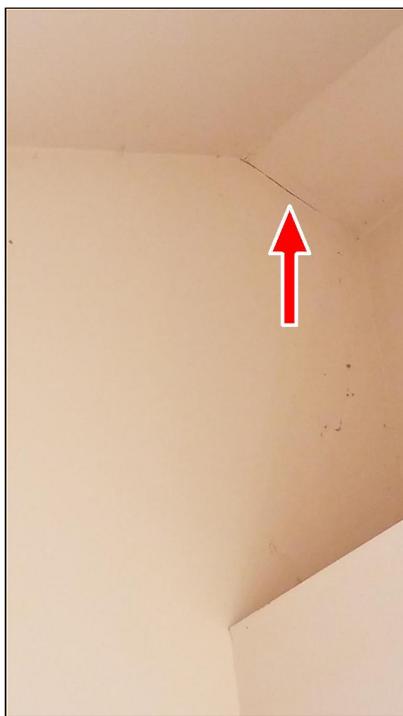
4.0 Item 1(Picture) crack in ceiling

There is a crack in the drywall in the master bath ceiling. Cracks can occur for a variety of reasons such as substandard drywall finishing, moisture in drywall seams, or cracks can be from movement/settlement of the home. Have a painter repair and paint the crack as needed. This crack appears cosmetic but if you are concerned the crack is from movement and is structural have an engineer evaluate the home.

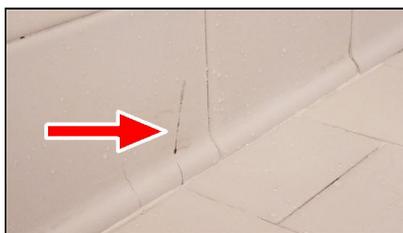
4.1 Item 2(Picture) cracked shower tile

(2) A cracked tile was noted in the master bath shower. Damaged tiles can let water from the shower enter the wall or floor cavities and hidden decay and mold growth can result. Have an experienced tile setter replace the damaged tiles.

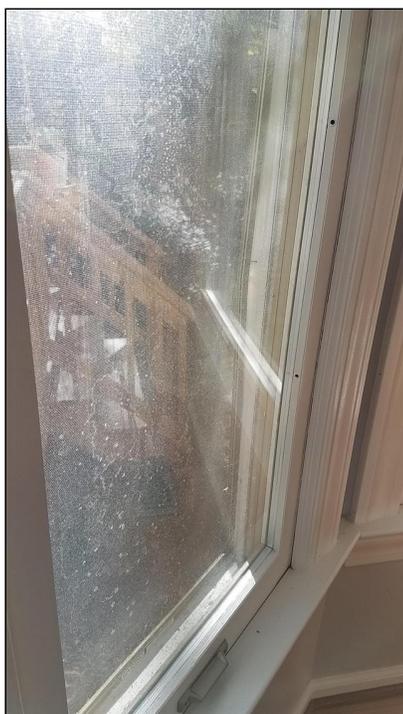
4.6 Item 1(Picture)

- (2) The left side of the bay window in the breakfast nook was fogged. "Fogging" is condensation trapped between two insulated glass panes and is caused by broken vapor seals. Fogging or cloudiness in windows may not be evident at the time of inspection but could appear during different weather conditions. Consider hiring a window specialist to evaluate all windows for broken seals and repairing as needed.

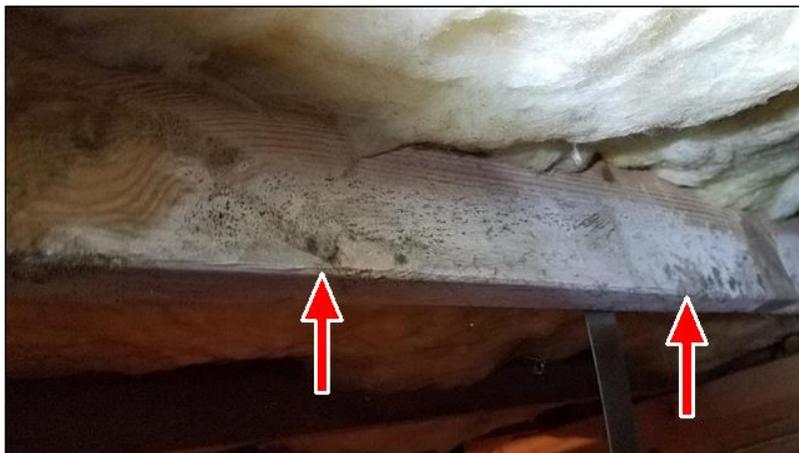
5.3 Item 1(Picture) mold/fungi

- (1) There is mold/fungi growth on the floor system in the crawlspace. The underlying cause of this growth is high humidity caused by moisture, wet conditions or standing water. Excessive moisture and a chronically moist environment will cause the moisture content of wood to increase. Wood with moisture content of 19% or greater provides the perfect conditions for wood decay fungi to grow. The activity of wood decay fungi results in wood rotting, destroying the structural integrity of the wood components in the crawl space. I did not test or determine if this growth is or is not a health hazard. Fungi growth can result in poor air quality in the home. Contact a mold inspector or expert for investigation or correction if needed. Monitor your crawlspace periodically as part of a normal maintenance program for your home.

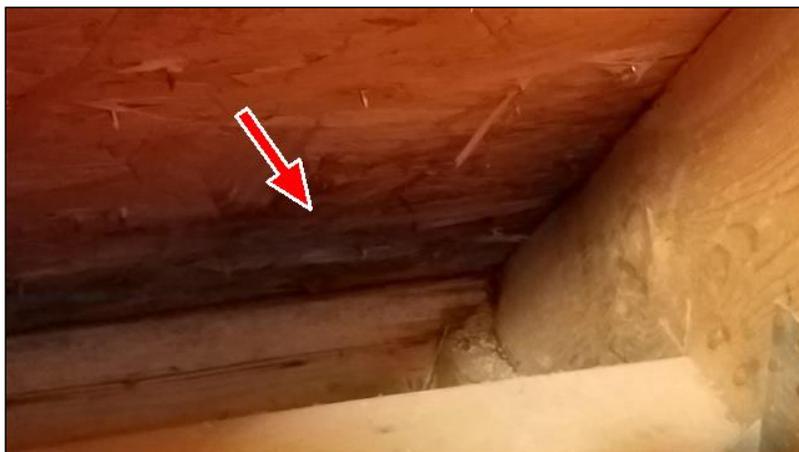
5.5 Item 1(Picture) water penetration

(1) The roof sheathing in the attic over the garage at the front of the house is stained from a roof leak. I am unable to determine if the leak is old and been repaired or still remains active. Although the damage to this area is not significant enough to require replacing at this time, an active leak can cause structural damage and decay of building components if not corrected. Have a licensed roofing contractor evaluate the roof and make any necessary repairs to keep water out of the attic.

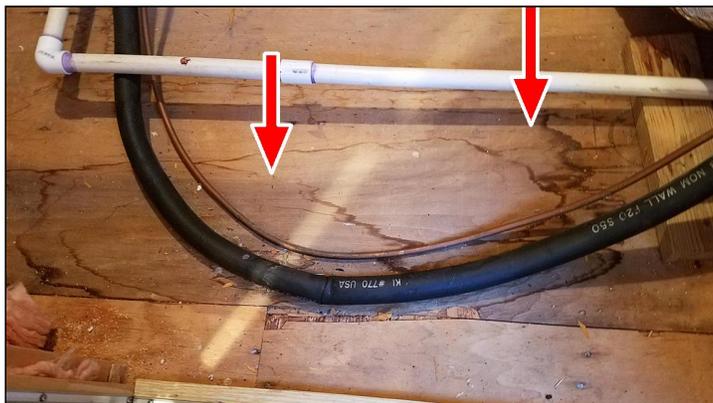
5.5 Item 2(Picture) water stains

(4) There are water stains on the attic flooring under the HVAC air handler located in the attic above the master bedroom. It appears that the stains are from condensation dripping off the HVAC piping. While there was no active water leaking during the inspection and the damage is not significant, I could not determine if the condition causing the water has been corrected. Water actively entering into the attic can cause damage to ceilings, wood components and insulation. Monitor the area for signs of water and have an HVAC technician evaluate the air handler and make sure that any condensation that forms is drained to the exterior.

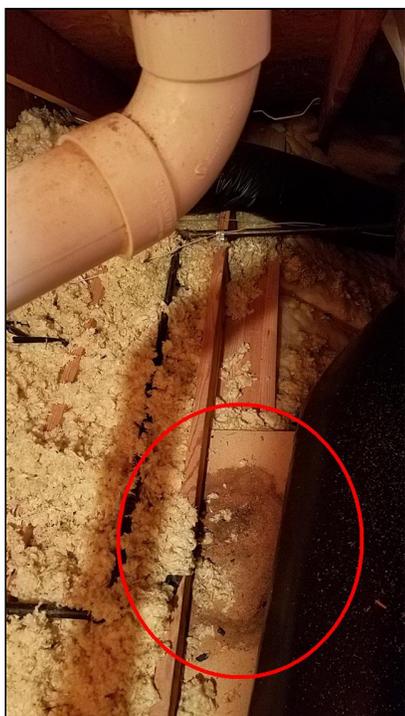
5.5 Item 3(Picture) leak stain

(5) I noted a water stain on the attic flooring above the master bath directly below where a plumbing vent pipe penetrates the roof. This frequently happens if the pipe flashing boot is old and damaged allowing water to drip into the attic around the pipe. There were no signs of active water leaks at the time of the inspection and the pipe flashing boot was in good shape. Have the home owner disclose if any repairs were made to correct a leak around the vent pipe. Also check the area for water leaks after a heavy rain to be sure the problem has been fixed.

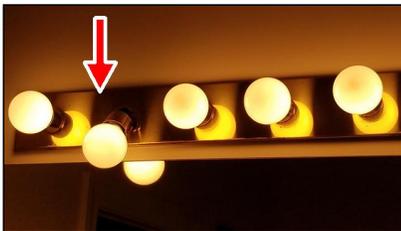
7.5 Item 2(Picture) damaged light fixture

(2) The light fixture in the master bathroom is damaged and needs to be replaced by a licensed electrical contractor.

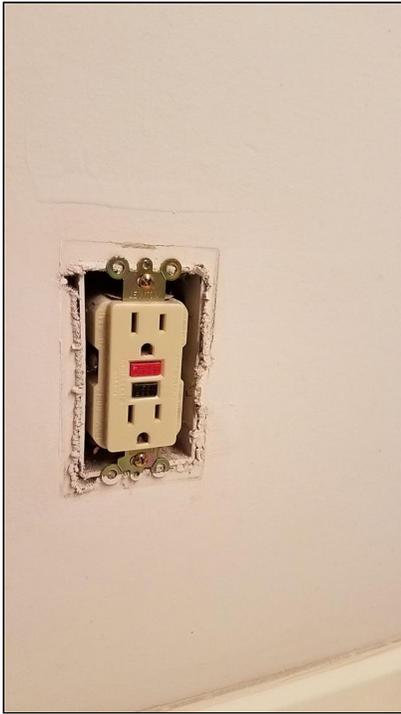
7.6 Item 1(Picture) missing cover plate

(1) A receptacle in the master bath is missing it's cover plate that prevents accidental contact with live electrical conductors. This is a dangerous shock hazard that should be corrected. Have an electrician or handyman install a cover plate.
